**Flood Control Project Maintenance
Levee Inspections**

Maintenance Issue Types Only, Levee Inspection Report By Mile - Spring 2016

Sutter Maintenance Yard East Levee Sutter Bypass

Waterway	Bank	Unit Miles	Inspection Start/End	Inspector
Unit No. 01 Sutter Bypass Levee	Left	21.68	03/23/2016 03/23/2016	Keith Millard

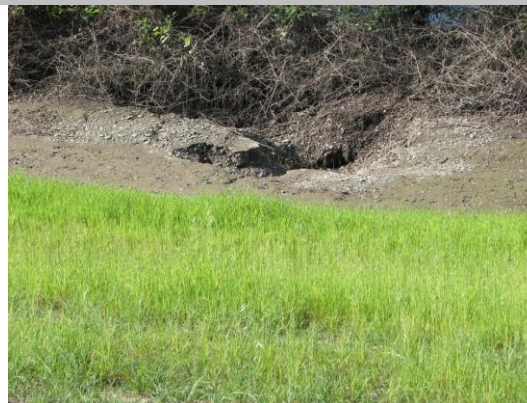
Photo 1 of 1 : SP_2016_ST0002_450_27_20160405_00039.jpg

LM Start	1.57	Rating **	U	Issue No.	27
LM End	1.57	Issue Type +	Ma	Location *	WS
Category	Earthen Levee			GPS Latitude/Longitude	
				Start	End
Item	Erosion / Bank Caving			39.136984 °	39.136984 °
				-121.809686 °	-121.809686 °
DWR ID	DWR_ST0002_01_s_2016_27				
Comment Code					
E2 : Schedule repair of erosion site prior to the next inspection.					
Inspector Comment					
Active erosion of the waterside toe road migrating towards levee.

Erosion rut

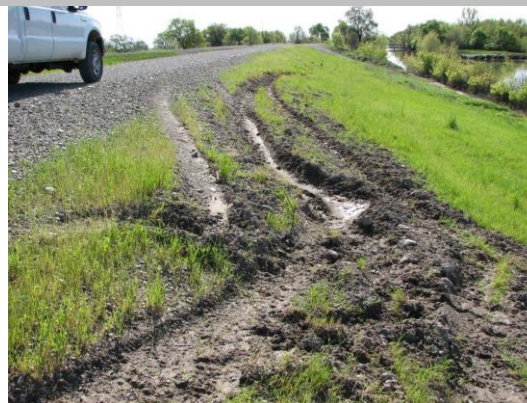
Photo 1 of 1 : SP_2016_ST0002_450_28_20160405_00040.jpg

LM Start	4.14	Rating **	M	Issue No.	28
LM End	4.14	Issue Type +	Ma	Location *	WS
Category	Earthen Levee			GPS Latitude/Longitude	
				Start	End
Item	Slope Stability			39.115232 °	39.115232 °
				-121.770963 °	-121.770963 °
DWR ID	DWR_ST0002_01_s_2016_28				
Comment Code					
S3 : Repair the levee slope damaged by vehicle traffic and prevent access where possible.					
Inspector Comment					
Vehicle traffic on slope has deep ruts and ponding of water.

Tire ruts

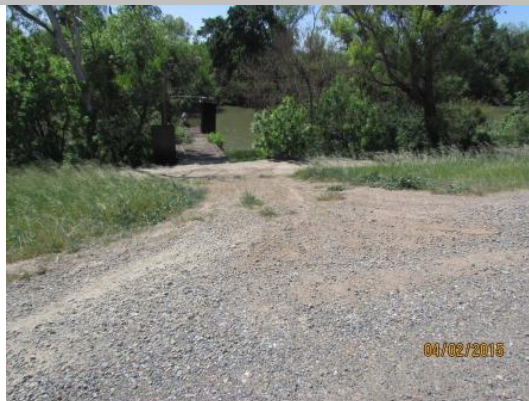
Photo 1 of 1 : SP_2016_ST0002_450_25_20160316_00005.jpg

LM Start	5.20	Rating **	A/W	Issue No.	25
LM End	5.20	Issue Type +	Ma	Location *	WS
Category	Earthen Levee			GPS Latitude/Longitude	
				Start	End
Item	Slope Stability			39.103313 °	39.103313 °
				-121.758813 °	-121.758813 °
DWR ID	DWR_ST0002_01_s_2015_25				
Comment Code					
S3 : Repair the levee slope damaged by vehicle traffic and prevent access where possible.					
Inspector Comment					
Repair the vehicle erosion along the waterside slope.

View of the vehicle erosion along the waterside slope.

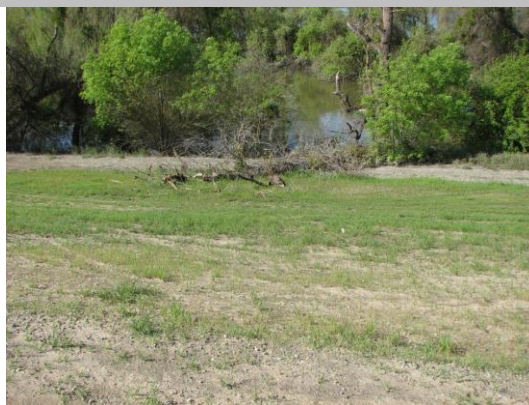
Photo 1 of 1 : SP_2016_ST0002_450_31_20160405_00041.jpg

LM Start	6.60	Rating **	M	Issue No.	31
LM End	6.60	Issue Type +	Ma	Location *	WS
Category	Earthen Levee			GPS Latitude/Longitude	
				Start	End
Item	Trim / Thin Trees			39.084236 °	39.084236 °
				-121.749914 °	-121.749914 °
DWR ID	DWR_ST0002_01_s_2016_31				
Comment Code					
T3 : Trim and thin trees to allow visibility of the ground and room to flood fight.					
Inspector Comment					
Fallen dead tree on waterside levee slope.

Downed tree on slope

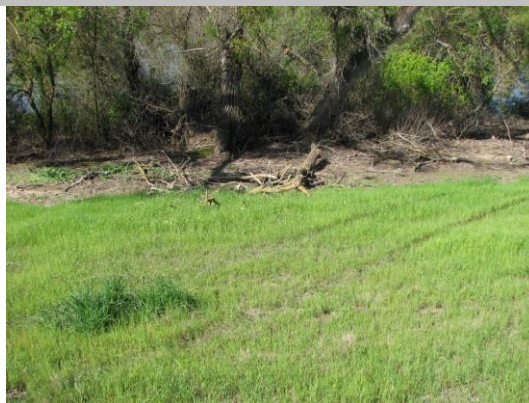
Photo 1 of 1 : SP_2016_ST0002_450_32_20160405_00042.jpg

LM Start	9.66	Rating **	M	Issue No.	32
LM End	9.66	Issue Type +	Ma	Location *	WS
Category	Earthen Levee			GPS Latitude/Longitude	
				Start	End
Item	Trim / Thin Trees			39.042003 °	39.042003 °
				-121.732308 °	-121.732308 °
DWR ID	DWR_ST0002_01_s_2016_32				
Comment Code					
T3 : Trim and thin trees to allow visibility of the ground and room to flood fight.					
Inspector Comment					
Fallen Dead Tree on Waterside slope.

Downed tree obstructing access

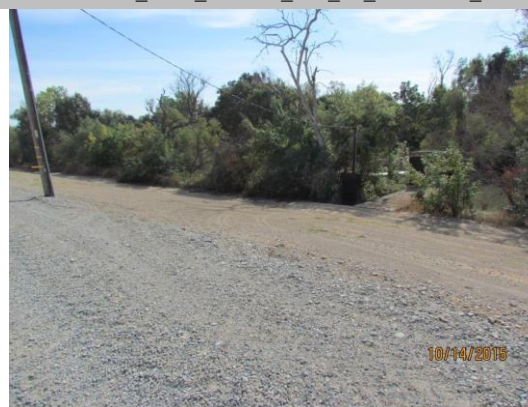
Photo 1 of 1 : SP_2016_ST0002_450_23_20160316_00004.jpg

LM Start	13.34	Rating **	A/W	Issue No.	23
LM End	13.34	Issue Type +	Ma	Location *	WS
Category	Earthen Levee			GPS Latitude/Longitude	
				Start	End
Item	Slope Stability			38.991857 °	38.991857 °
				-121.711555 °	-121.711555 °
DWR ID	DWR_ST0002_01_s_2015_23				
Comment Code					
S3 : Repair the levee slope damaged by vehicle traffic and prevent access where possible.					
Inspector Comment					
Repair the erosion along the waterside slope.

View of the vehicle erosion along the slope.

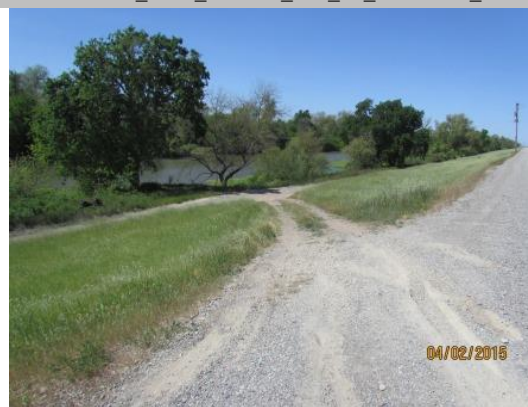
Photo 1 of 2 : SP_2016_ST0002_450_21_20160316_00002.jpg

LM Start	17.60	Rating **	M	Issue No.	21
LM End	17.60	Issue Type +	Ma	Location *	WS
Category	Earthen Levee			GPS Latitude/Longitude	
				Start	End
Item	Slope Stability			38.949965 °	38.949965 °
				-121.653823 °	-121.653823 °
DWR ID	DWR_ST0002_01_s_2015_21				
Comment Code					
S3 : Repair the levee slope damaged by vehicle traffic and prevent access where possible.					
Inspector Comment					
Repair the vehicle erosion along the waterside slope.

View of the vehicle erosion along the waterside slope.

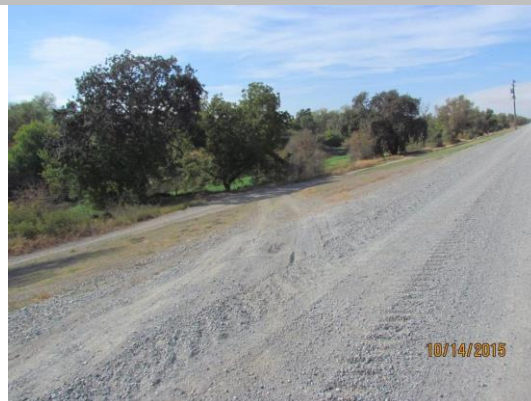
Photo 2 of 2 : SP_2016_ST0002_450_21_20160316_00003.jpg

LM Start	17.60	Rating **	M	Issue No.	21 (cont)
LM End	17.60	Issue Type +	Ma	Location *	WS
Category	Earthen Levee			GPS Latitude/Longitude	
				Start	End
Item	Slope Stability			38.949965 °	38.949965 °
				-121.653823 °	-121.653823 °
DWR ID	DWR_ST0002_01_s_2015_21				
Comment Code					
S3 : Repair the levee slope damaged by vehicle traffic and prevent access where possible.					
Inspector Comment					
Repair the vehicle erosion along the waterside slope.

View of the vehicle erosion along the waterside slope.

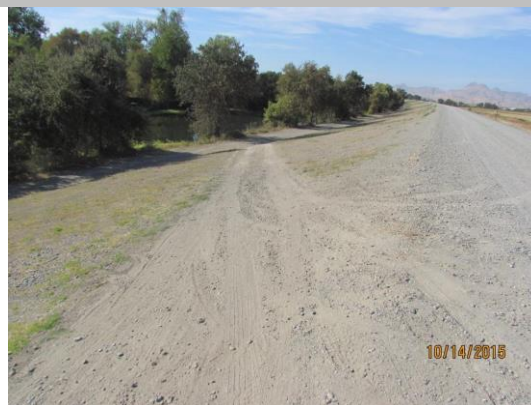
Photo 1 of 1 : SP_2016_ST0002_450_29_20160316_00006.jpg

LM Start	20.02	Rating **	M	Issue No.	29
LM End	20.02	Issue Type +	Ma	Location *	WS
Category	Earthen Levee			GPS Latitude/Longitude	
				Start	End
Item	Slope Stability			38.922678 °	38.922678 °
				-121.625890 °	-121.625890 °
DWR ID	DWR_ST0002_01_f_2015_29				
Comment Code					
S3 : Repair the levee slope damaged by vehicle traffic and prevent access where possible.					
Inspector Comment					
Repair the erosion along the waterside slope.

View of the vehicle erosion along the waterside slope.

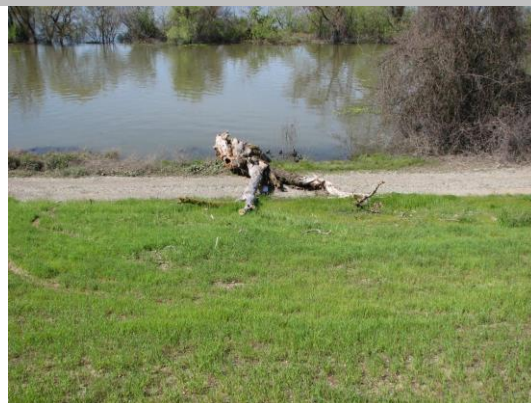
Photo 1 of 1 : SP_2016_ST0002_450_33_20160405_00043.jpg

LM Start	20.18	Rating **	M	Issue No.	33
LM End	20.18	Issue Type +	Ma	Location *	WS
Category	Earthen Levee			GPS Latitude/Longitude	
				Start	End
Item	Trim / Thin Trees			38.920461 °	38.920461 °
				-121.625193 °	-121.625193 °
DWR ID	DWR_ST0002_01_s_2016_33				
Comment Code					
T3 : Trim and thin trees to allow visibility of the ground and room to flood fight.					
Inspector Comment					
Fallen dead tree on waterside slope.

Downed tree obstructing access
